# MORGAN STREET RESERVOIRS ALTERNATIVES ANALYSIS REPORT

City of Oberlin, Ohio

September 21, 2020

## ALTERNATIVES ANALYSIS REPORT

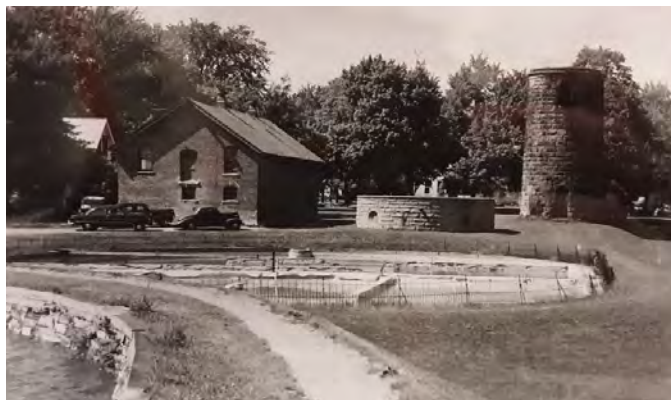
**FIGURE 5 - VIEW OF HISTORIC INFRASTRUCTURE - LOOKING NORTH**

Today the structures are still standing but the rear addition of the Service Building sustained significant fire damage including the destruction of the existing roof rafters, heavy heat damage to the existing masonry, and destruction of the mezzanine and stairs. The original portion of the building sustained minor heat, water, and smoke damage as well as damage to the existing doors. The City performed a separate architectural analysis that concluded with the recommendation of a modest restoration. This proposed restoration includes the

demolition of the old addition, necessary code upgrades to the original structure, repointing of the brick, new windows and door repairs and replacement, with new utilities including electrical, water and sewer services. Future renovation of the Service Building is a separate project and not included within the scope of EDG's work.

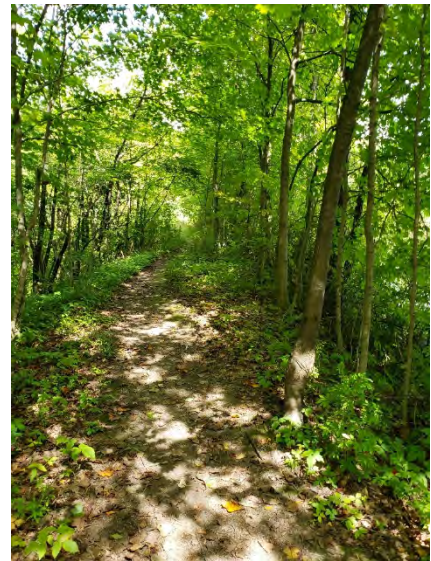
**FIGURE 12 - SHARED EARTHEN EMBANKMENT BETWEEN THE RESERVOIRS**

The Slope Stability Analysis calculated the earthen embankment between the reservoirs has a factor of safety (FOS) of 1.06 under rapid draw down conditions and a FOS of 1.25 under steady state conditions. A FOS above 1.3 indicates a stable condition, while a FOS below 1.0 indicates a high probability of slope instability and/or occurring failures. Since the FOS falls into the area between 1.0 (unstable) and 1.3 (stable), it is determined the reservoirs could not function as a single unit and therefore cannot be regulated as two separate reservoirs without significantly reinforcing the existing earthen embankment.

Further recommendations include avoiding rapid drawdown of Reservoir No. 2 and repairing all eroded areas along Reservoir No. 1. It is also recommended that after Reservoir No. 2 is drained, a perforated drain be installed along the west toe of slope. The full report, dated November 25, 2019 is included in Appendix C.

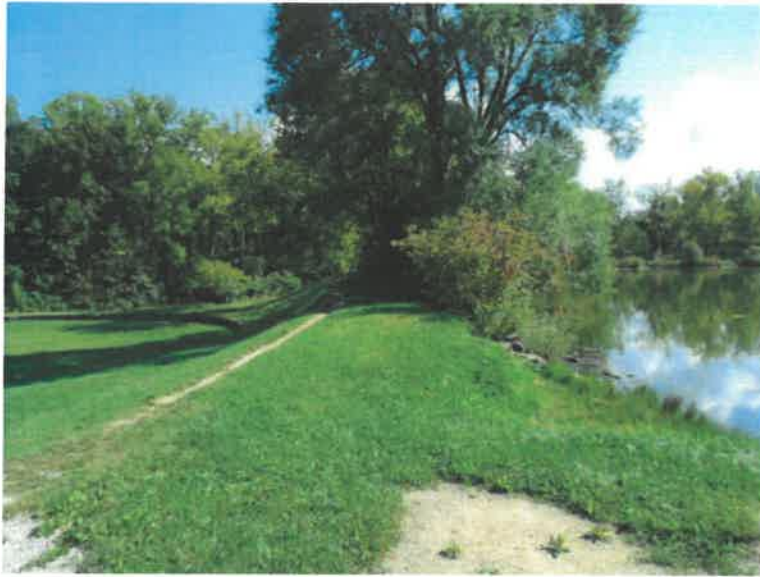
1. The east embankment along Reservoir No. 1.

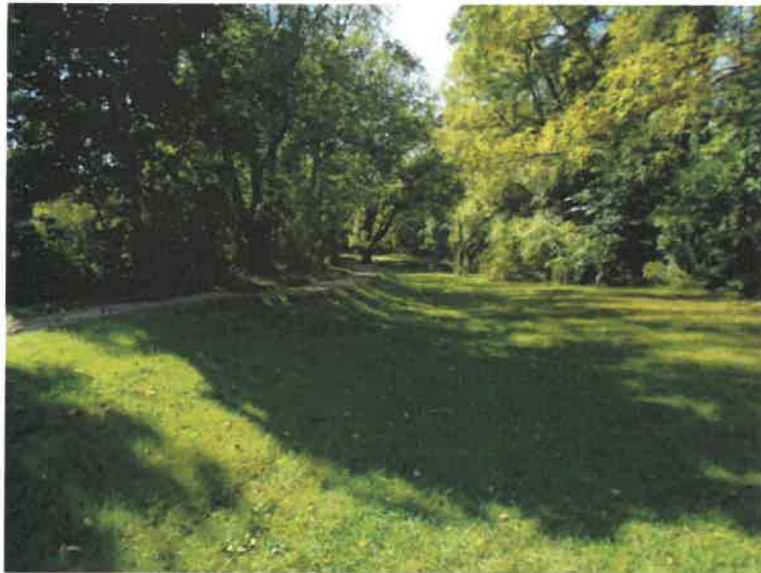
2. The north embankment along Reservoir No.1.

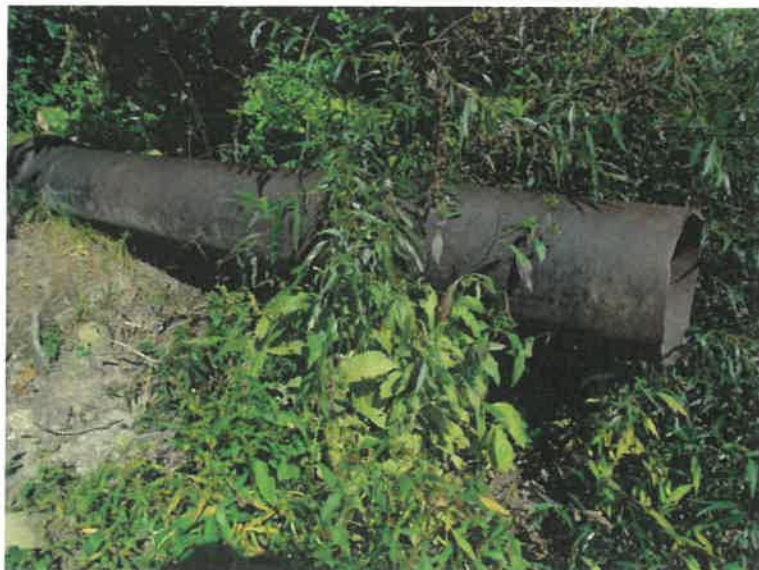
3. One of multiple unused piping located within the embankment.

4. The unused and abandoned piping must be removed or properly abandoned. Prepared plans and specifications for removal or abandonment. The conditions of the unused and abandoned piping must be monitored quarterly until repairs can be made.

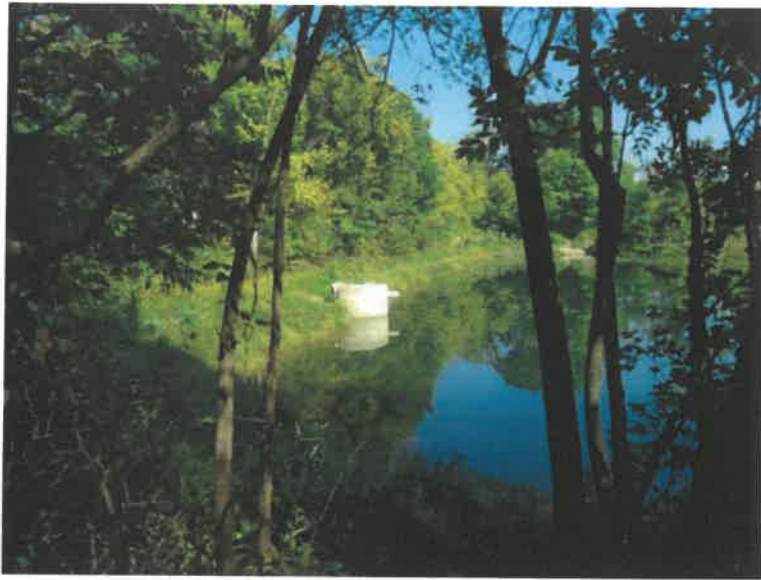
4. The old masonry riser in Reservoir No. 2.

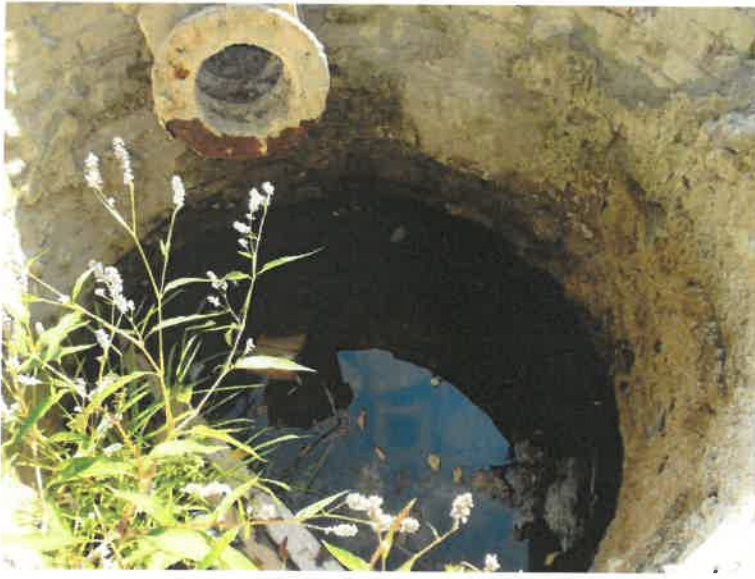
5. Interior of the masonry riser.

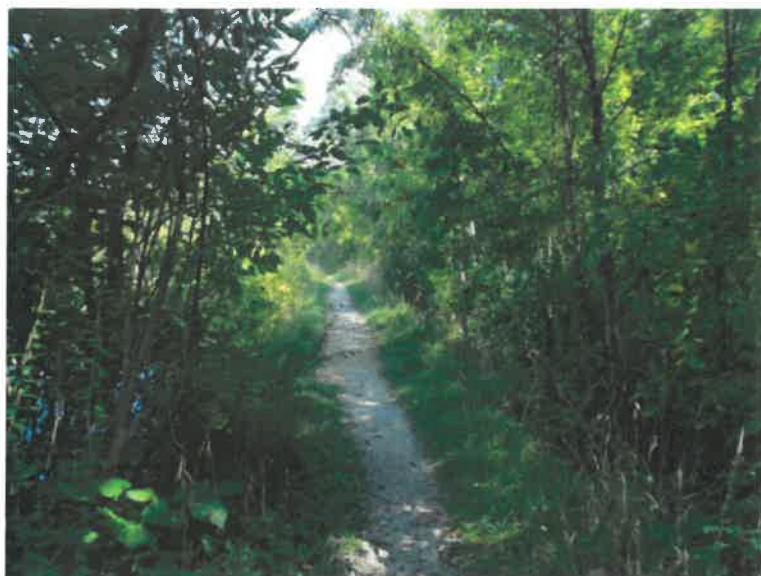
10. The embankment along Reservoir No. 1.

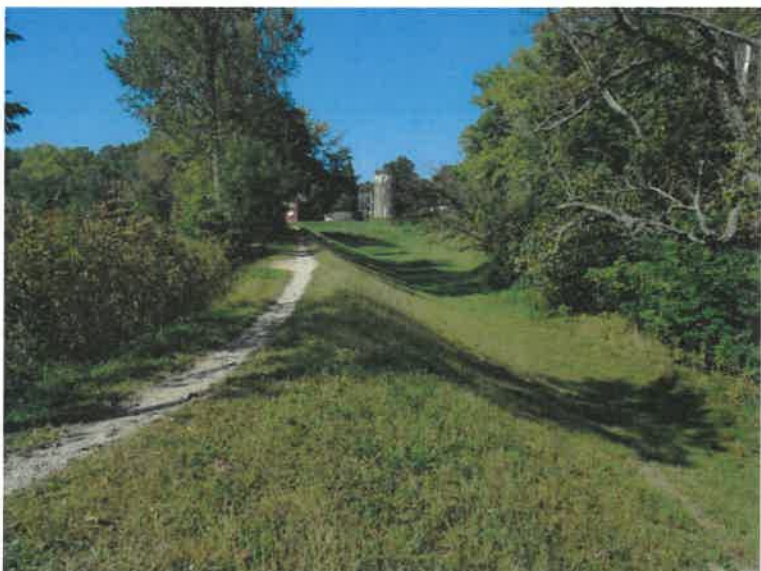
11. The east embankment along Reservoir No. 1.

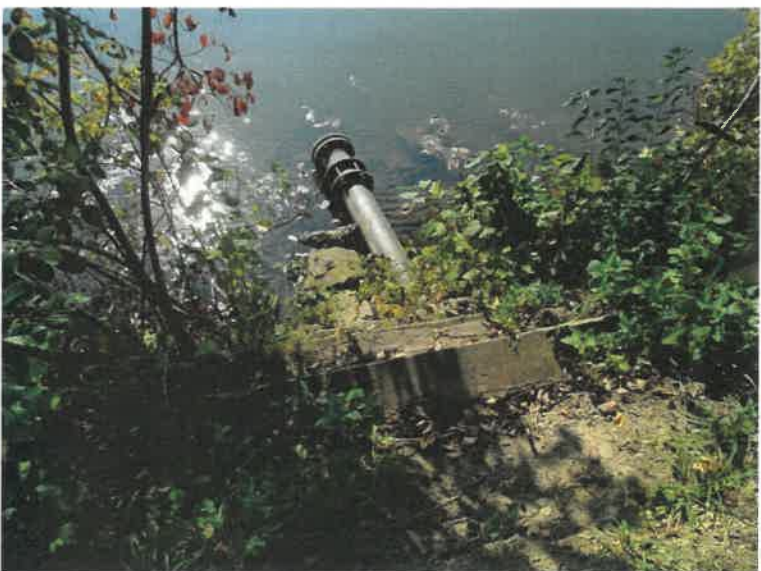
12. The emergency overflow pipe located in Reservoir No. 1.

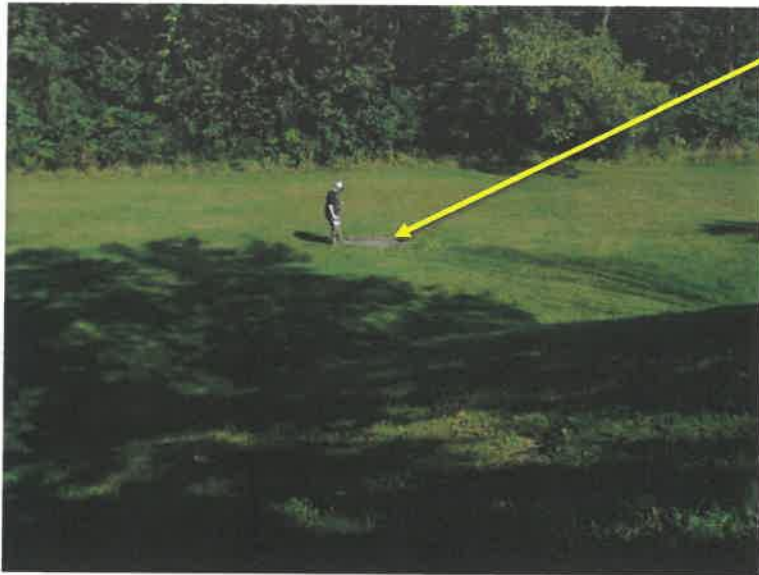
13. The emergency overflow pipe catch basin located at the exterior toe of Reservoir No. 1.

6. Repair the footpaths on the crest.
7. Remove the obstructions from the emergency overflow catch basin. Repair the low areas on the crest of the main embankment.

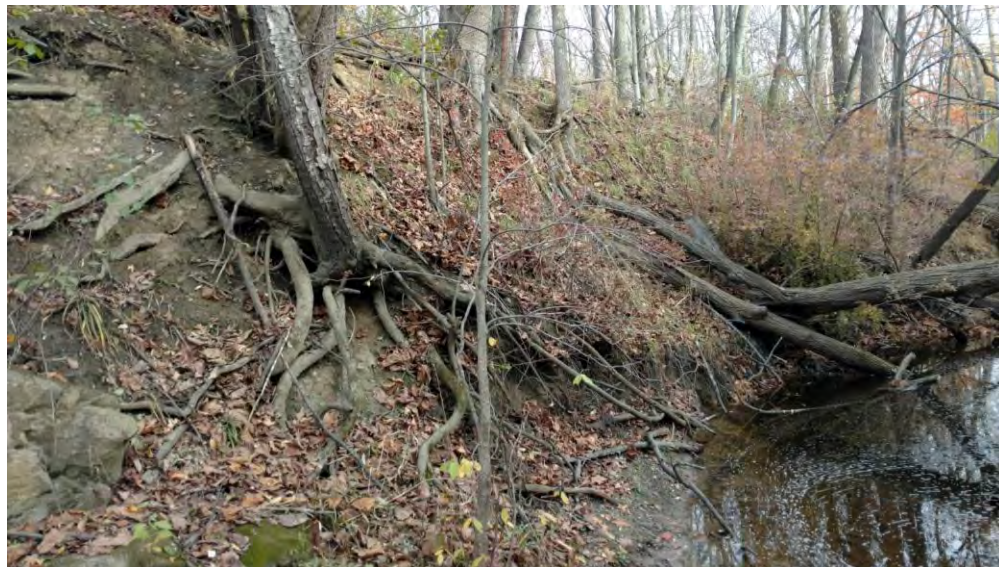
The terrain along the south embankment and at the southeast corner of reservoir No. 1 beyond the earthen berm consisted of a narrow relatively mild graded plateau over a steep drop into Plum Creek. CTL noted ongoing natural erosion along the boundary between the creek and the reservoir. Based on visual observations during the reconnaissance, CTL did not notice slope failures of the existing embankments, we noted the erosion and the irregularities as stated in the ODNR Safety Inspection Report.

*Photograph 1: Toe Erosion near Plum Creek at SE of Reservoir #1.*
