## **Plum Creek Riparian Corridor Survey**

**8/1/2005**

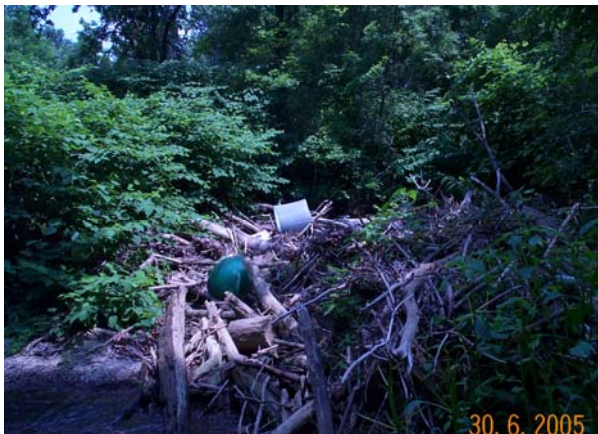
Log and debris jams are numerous along Plum Creek. 65 log and debris jams were observed in the survey area, though these vary greatly in the extent of their blockage of the watercourse—more than half of these sites were designated as jams because they may pose a future problem as they collect more debris. GPS point comments and photos taken will help locate the priority actions to be taken in clearing these jams. Further research and planning should categorize these debris jams as: 1.) useful as wildlife habitat; 2.) jams possibly problematic in the future; 3.) priority situations in which clearing jams would greatly improve normal creek flow, storm flow, etc. A priority list of the 10 most severe debris jams has been designated on the AutoCAD map of the survey area, denoted on the *Log and Debris Jams* layer with a lighter orange color.

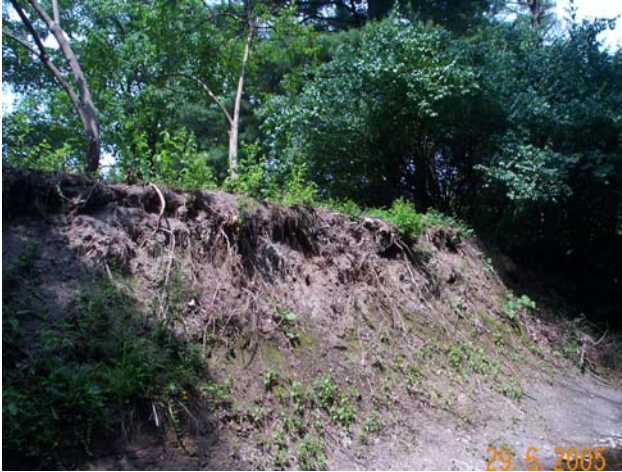
Though there are many erosion and possible future erosion sites along Plum Creek, 8 particular sites were noted in the survey. Any actions to be taken at these sites can also be prioritized by photos and/or revisiting the site. Though categorized more explicitly

under another section heading, areas along the corridor with little or no riparian buffer zone pose the threat of current and future erosion. Several such sites are sections of the corridor that run through residential areas, where residents tend to mow much closer to the creek banks. Such human activities—and other natural processes of erosion—can increase the sediment load in the creek channel, which can begin to clog and slow creek flow, as well as negatively affect biotic life.

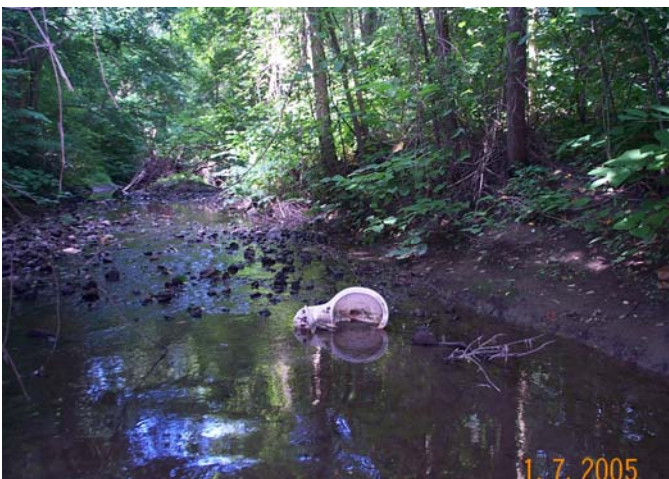
Trash is present to some extent in Plum Creek along the entire surveyed section of the corridor, but areas of heavy trash are concentrated and observable especially near all bridge crossings—both pedestrian and road crossings. Other places where trash appears in concentration are sections of the creek that course through the city parks (Wright Park, King Memorial Park, Spring St. Park, the bike path crossing between Spring St. and College St., Roadside Park) and trash that is caught in existing major log/debris jams. Any clean-up efforts would best begin in these areas. A good start may be to remove trash from the creek bed 50-100 yards on both sides of each bridge crossing, and to check all creek frontages in the city parks that have narrow buffer strips.
