## Memorandum

**TO:** Mr. Chris Yates - Oberlin City Hall  
**FROM:** J. Alberts, P.E.; N. Kacynski, P.E.; B. Klingerman  
**DATE:** April 7, 2022  
**FKE PROJ. NO:** 22-025  
**SUBJECT:** Permanent Shoring System for Support of Existing Floor Slab  
Historic Gasholder Building  
Oberlin, Ohio

# OBERLIN GAS HOLDER BUILDING

CITY OF OBERLIN, OHIO

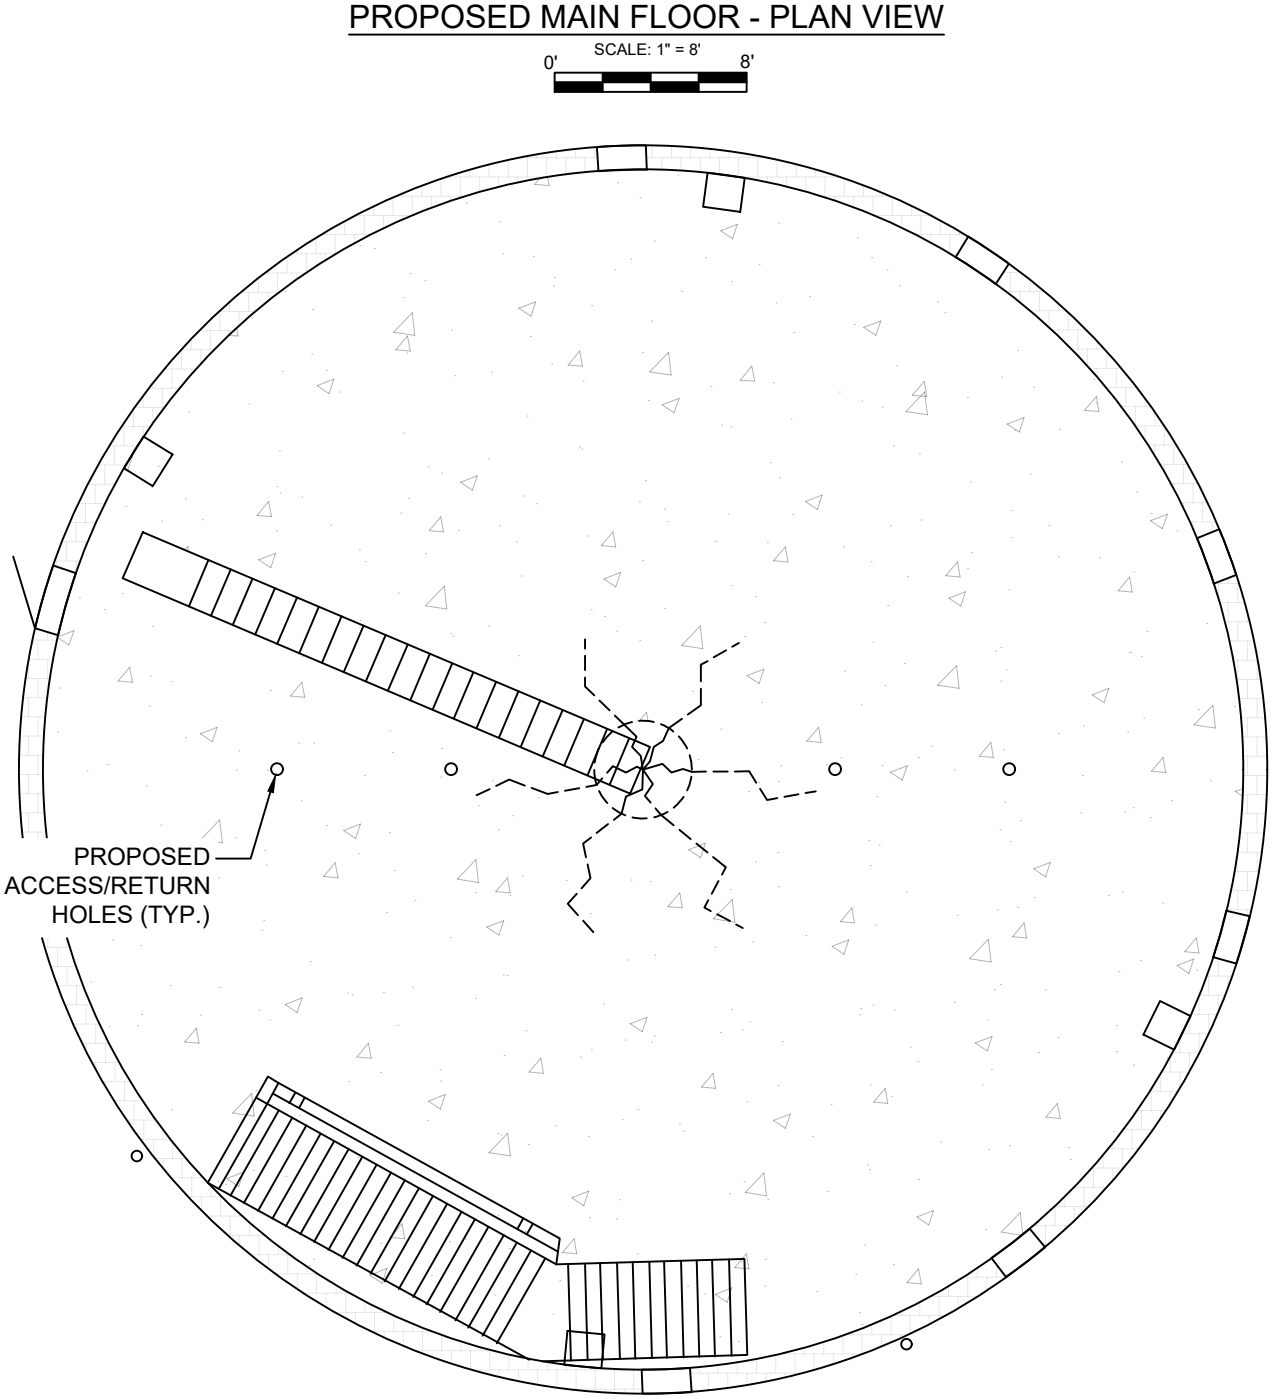
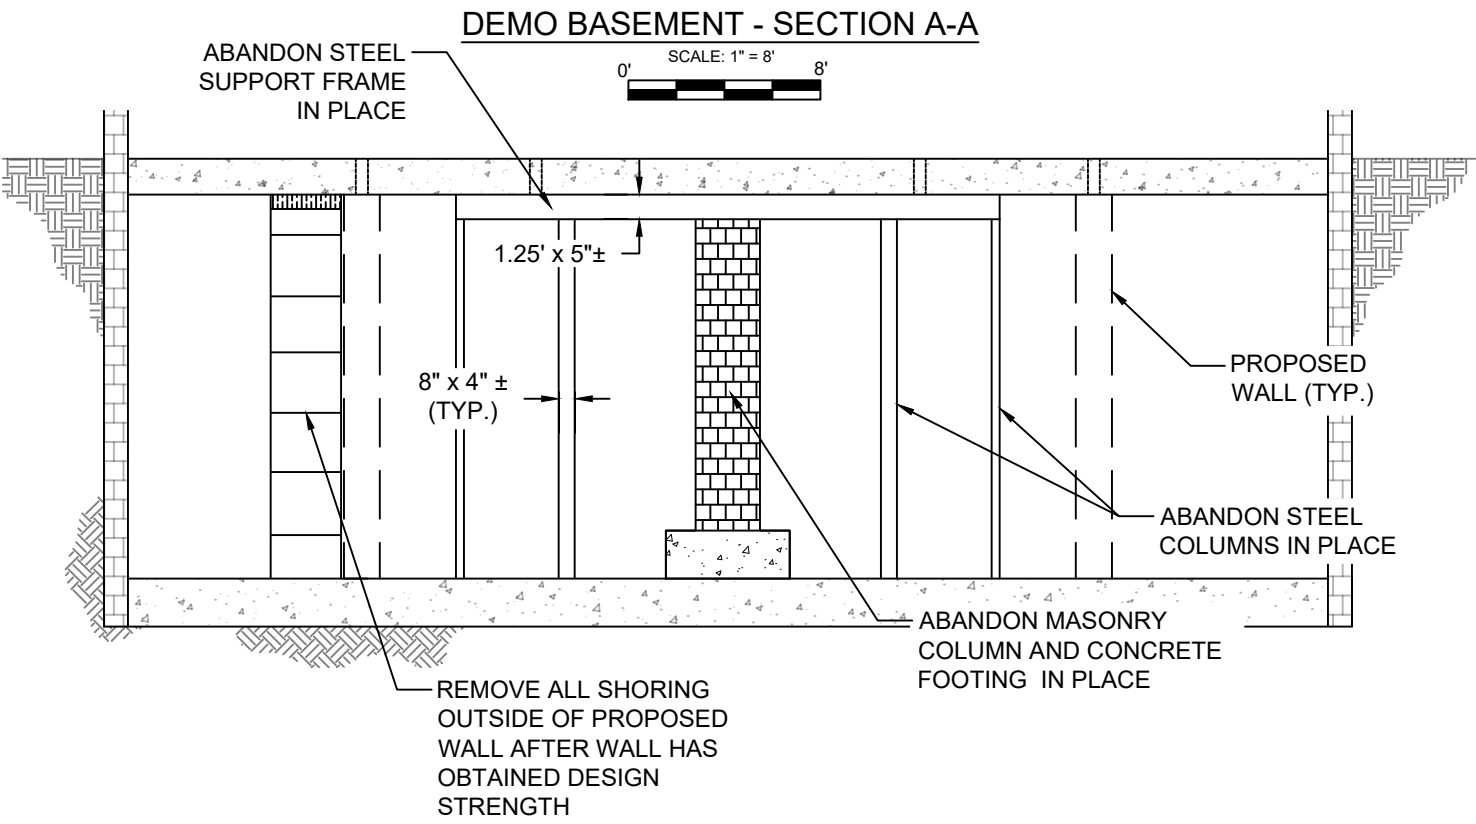
4

- CONSTRUCTION SEQUENCE:
1. THOROUGHLY POWERWASH, CLEAN AND REMOVE ALL LOSE DEBRIS FROM EXISTING BASEMENT FLOOR AND BOTTOM OF MAIN FLOOR.
  2. FORM AND POUR A MAXIMUM OF 8-FOOT HEIGHT OF THE SUPPORT WALL. ALLOW CONCRETE TO REACH COMPRESSIVE STRENGTH OF 3,000 PSI.

3. DRILL MINIMUM OF TWO 6-INCH DIAMETER HOLES IN THE EXISTING FLOOR SLAB. HOLES WILL BE USED TO ALLOW FOR PLACEMENT OF CONCRETE, PROVIDE VENTILATION, AND TO ALLOW MONITORING OF CONCRETE PLACEMENT.

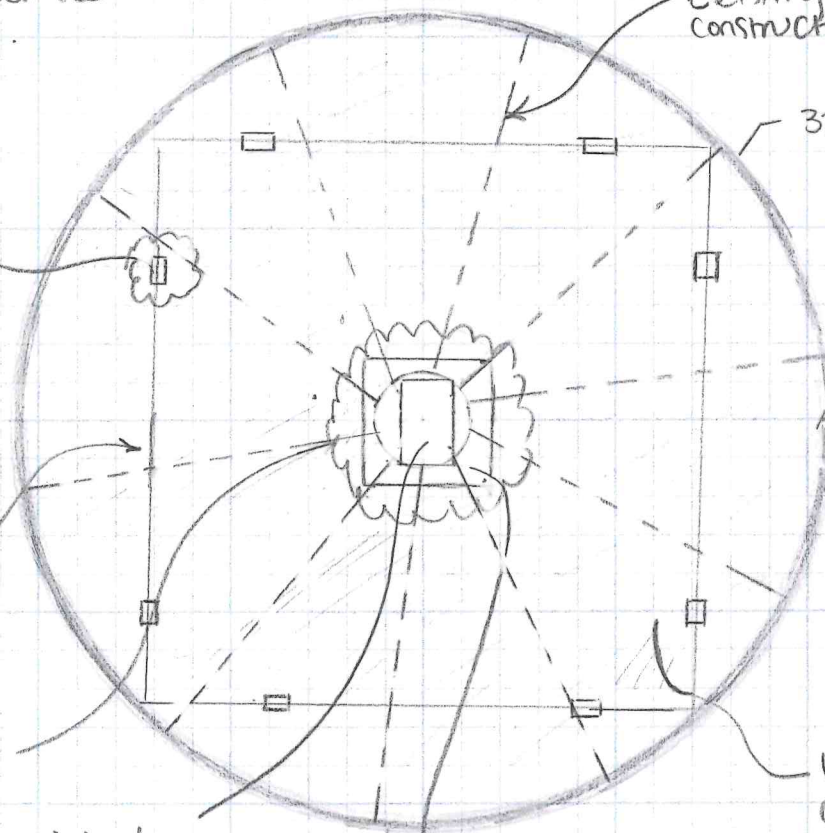
18" thick concrete  
Support wall.

lightweight  
cellular grout

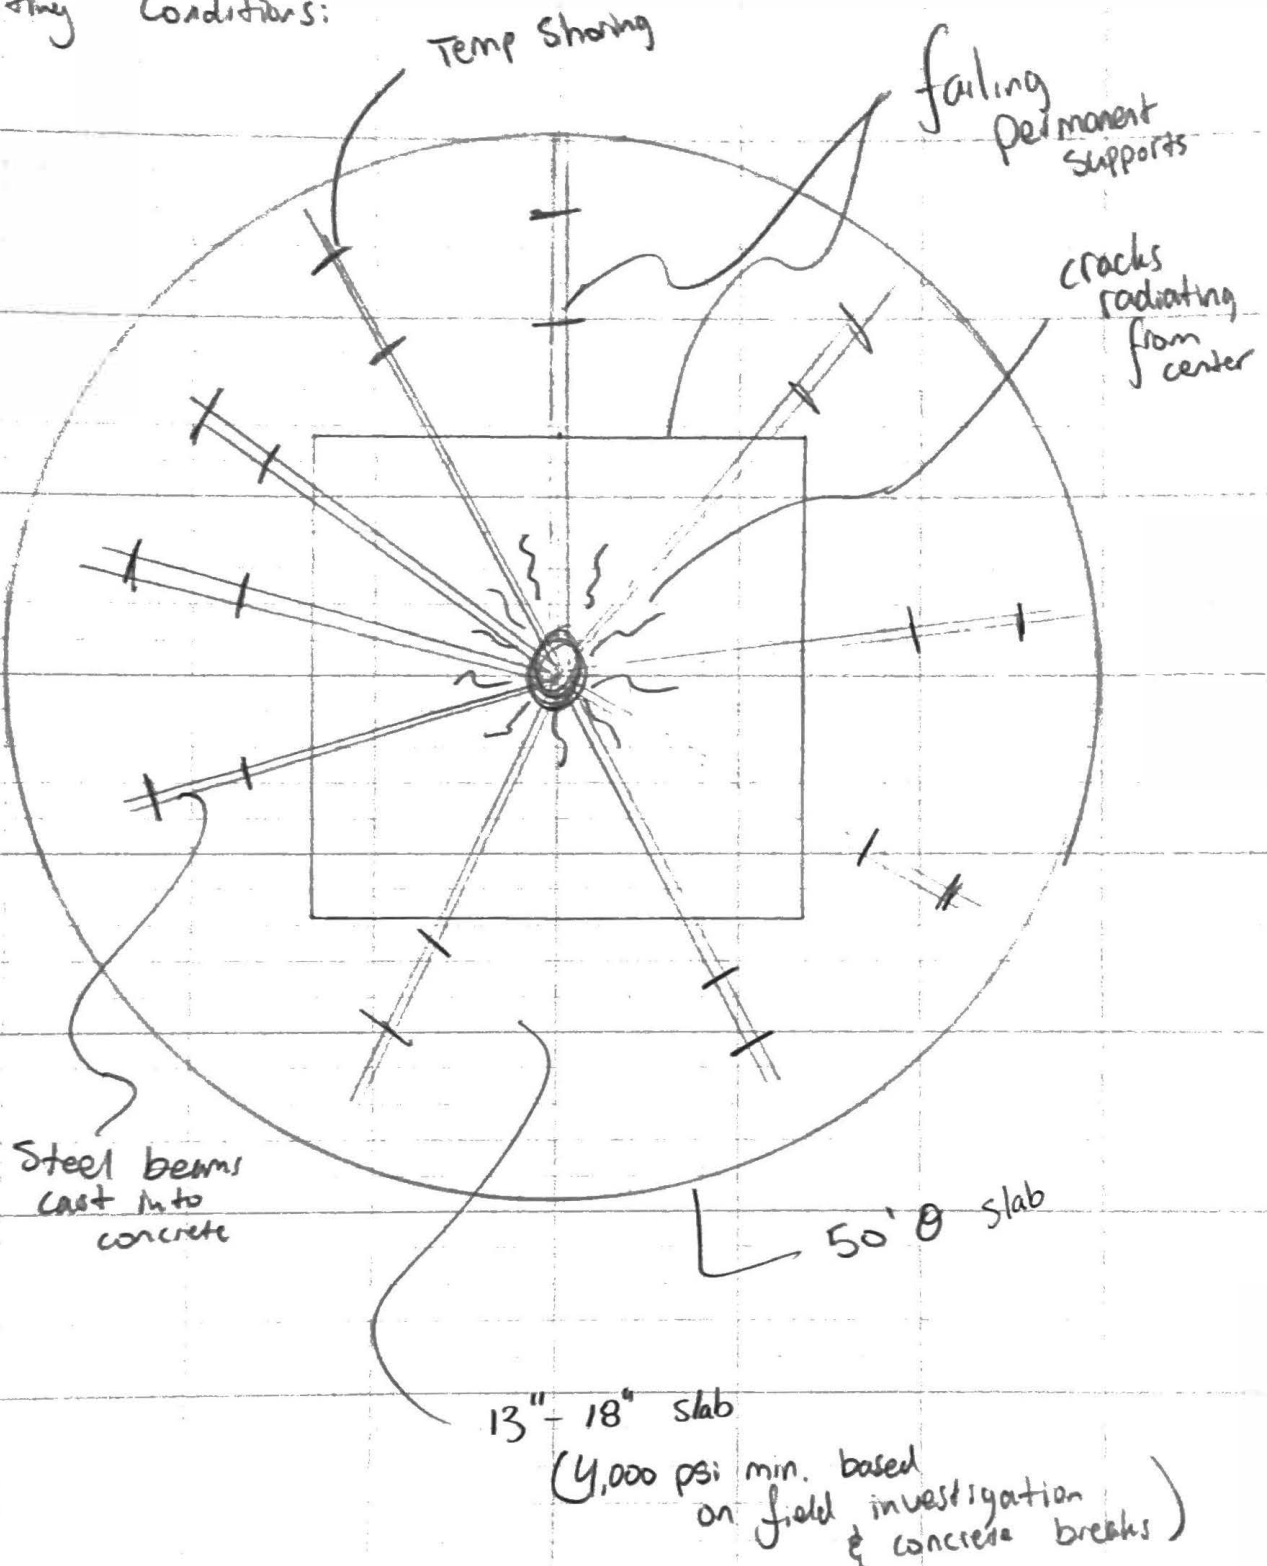
Existing Conditions:

The slab appears to be failing at its center, with cracking spreading outwards. Currently, shoring is in place to provide temporary support.

Existing permanent supports appear to be failing & @ a minimum have significant section loss based on a report prepared by others.

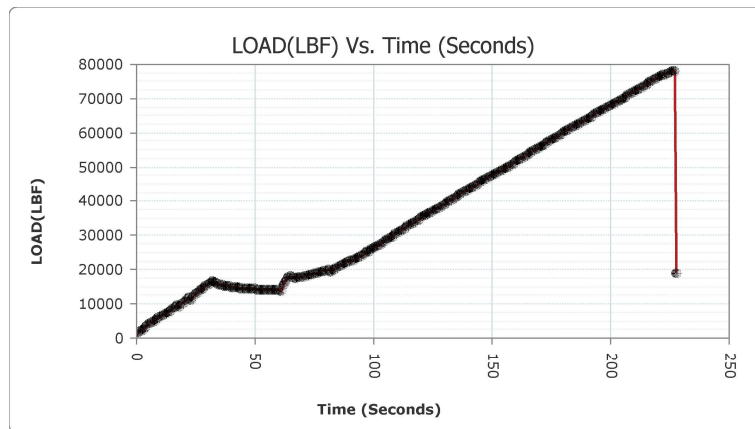
TYPE	PEAK VALUES	UNITS
LOAD	75004	LBF
Diameter	4.00	IN
Length	6.00	IN
Cross-Sectional Area	12.57	IN <sup>2</sup>
Sample Age	0.0	day(s)
Corrected Stress	5968.65	PSI
Average Pace Rate	32.40	PSI/SEC
Fracture Type	Type 3	
Correction Factor	0.960	
Temperature @ START	75.8	°F
Temperature @ FINISH	76.4	°F

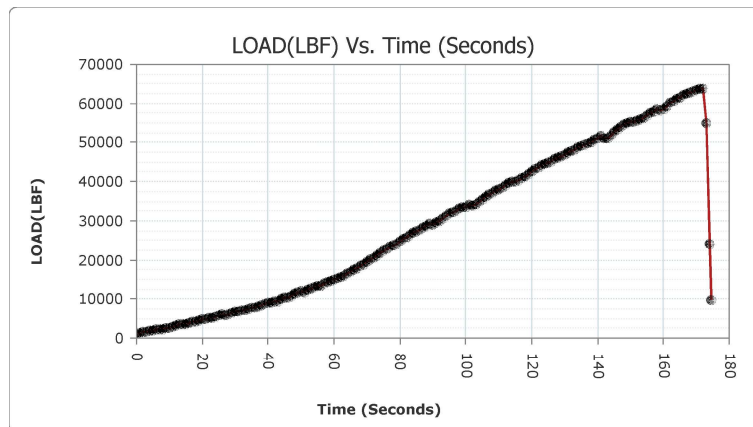
TYPE	PEAK VALUES	UNITS
LOAD	61302	LBF
Diameter	4.00	IN
Length	6.00	IN
Cross-Sectional Area	12.57	IN <sup>2</sup>
Sample Age	0.0	day(s)
Corrected Stress	4878.29	PSI
Average Pace Rate	33.55	PSI/SEC
Fracture Type	Type 3	
Correction Factor	0.960	
Temperature @ START	77.2	°F
Temperature @ FINISH	77.7	°F

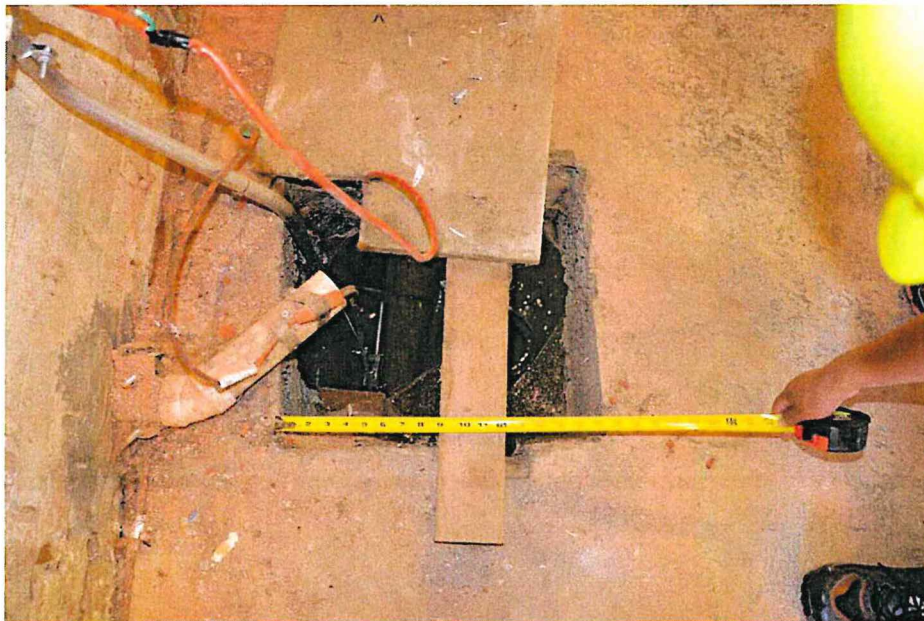
Photo 4. 18" X 18" Hole on the Main Floor

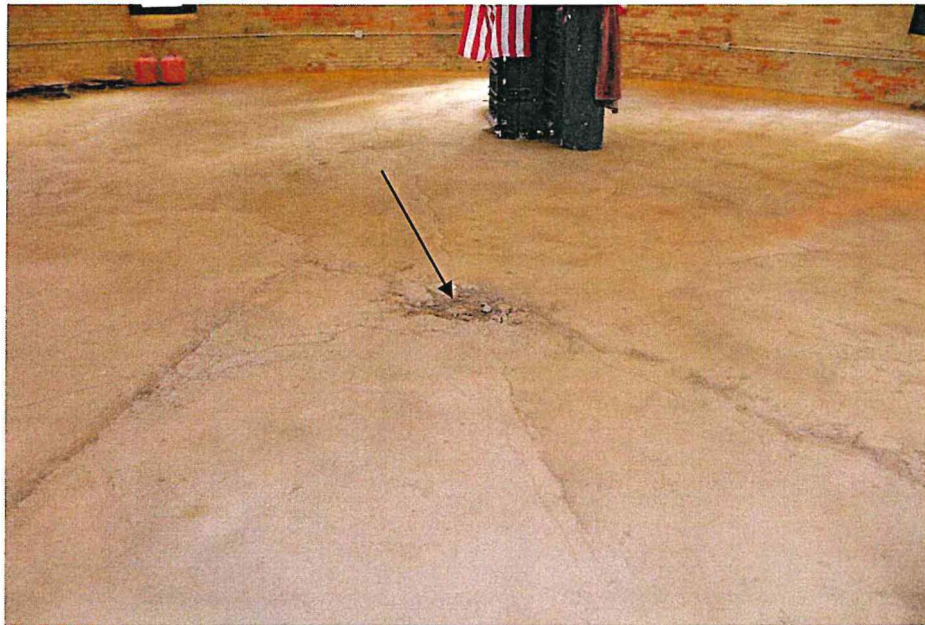
Photo 5. Center Area of the Round Main Floor

The concrete floor thickness varies from 11 to 13 inches and is approximately 50' in diameter. There are cracks in the concrete slab which radiate from the center of the floor with the areas surrounding the center being depressed several inches (Photo 5). The cracked center area sounds hollow and bouncing. Other areas are solid. There are four 18"x18" holes on the floor along the wall (Photo 4) with an open view of the basement or temporary covers in place. A 12'x4' portion of the existing slab has been previously removed to allow the installation of new timber stairs for basement access (Photo 7).

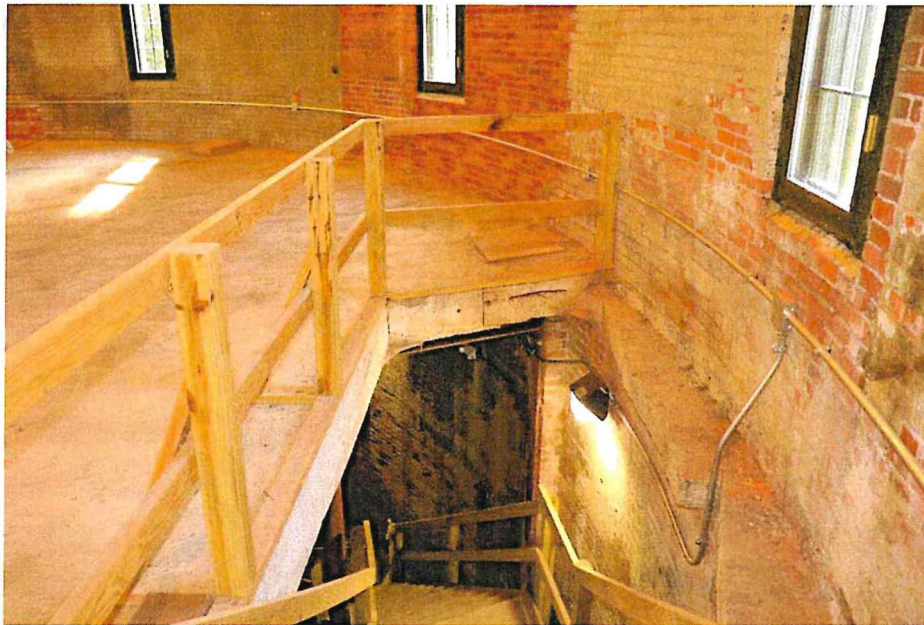
Photo 7. Opening on the Main Floor for Stairs to Basement

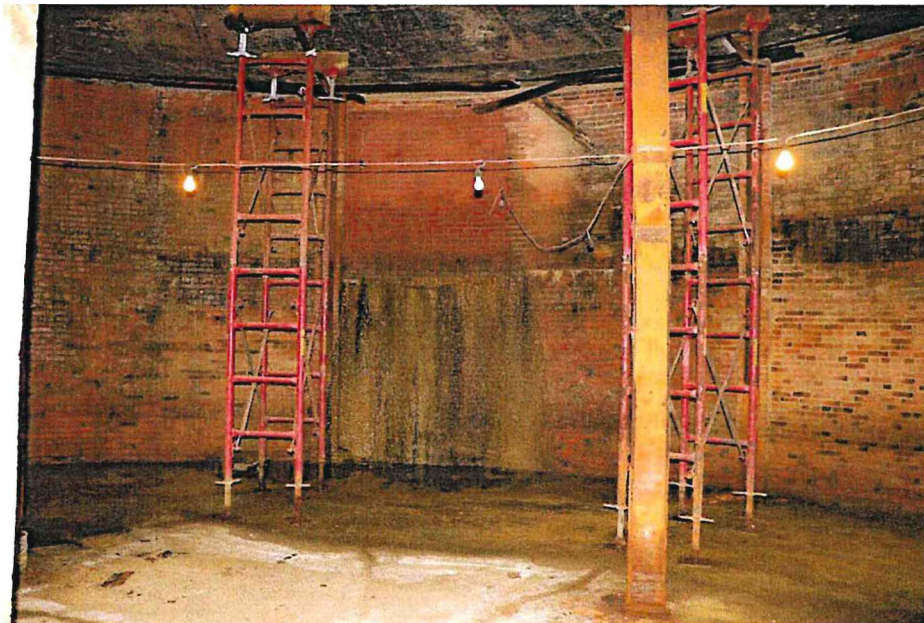
Photo 8. Active Leakage on the Basement Wall

1. General: The City of Oberlin informed KS that the basement, as part of the original structure's function, was flooded with water at one point and has been flooded for periods of time since the structure was decommissioned. Sump pump was installed to drain the accumulated water. KS used a Plumb Bob to verify that the basement walls are plumb and observed no signs of uneven settlement. There are signs of active leakage on the masonry basement wall, areas of cracked and wet floor (Photo 10), and ponding around the sump wells (Photo 12). The east wall of the basement has the heaviest evidence of infiltration with active leaking, heavy efflorescence/mineral buildup on the lower half of the wall and ponding at the floor below (Photo 8). See the attached defect map for the location of the leaking wall and ponding.

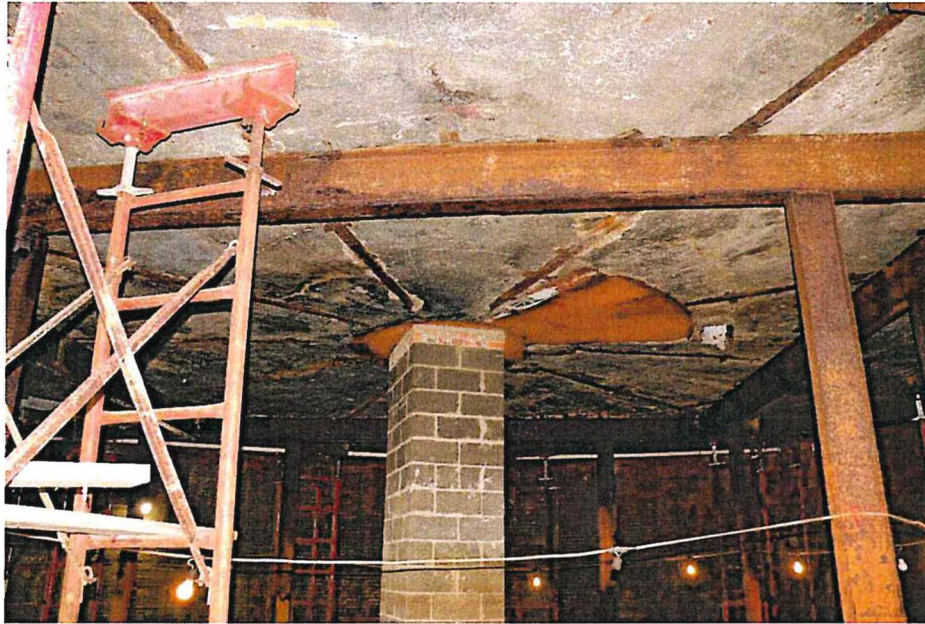
Photo 9. Center Masonry Column under the Main Floor

2. Center Masonry Column: The center masonry column (3'-4" X 2'-8") was installed in 2014 and is in good condition (Photo 9). The column is supported on the 6'-0" X 5'-2" concrete foundation and its concrete cap provides support for the embedded fanned steel beams.

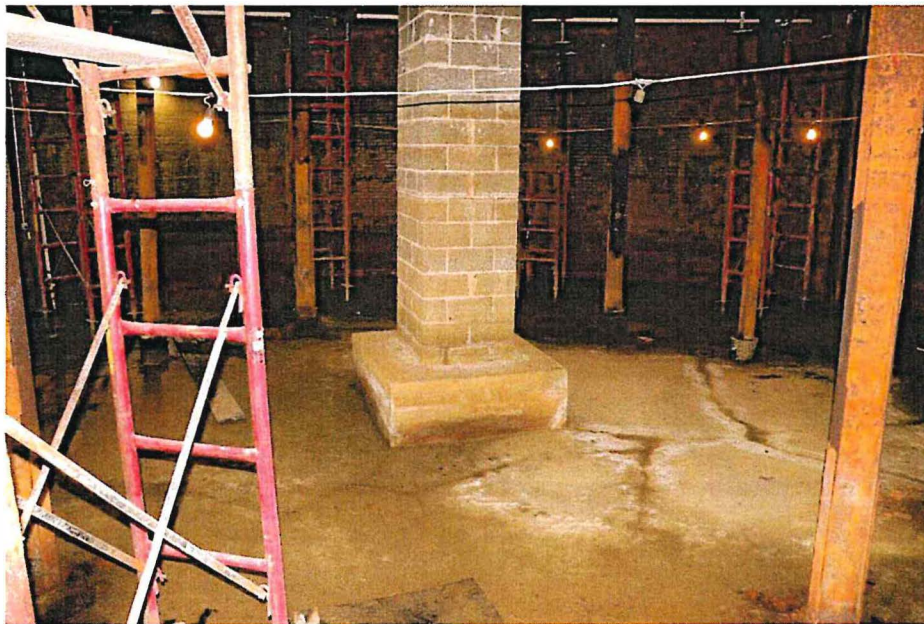
Photo 10. Basement Floor with Cracks and Wet Areas

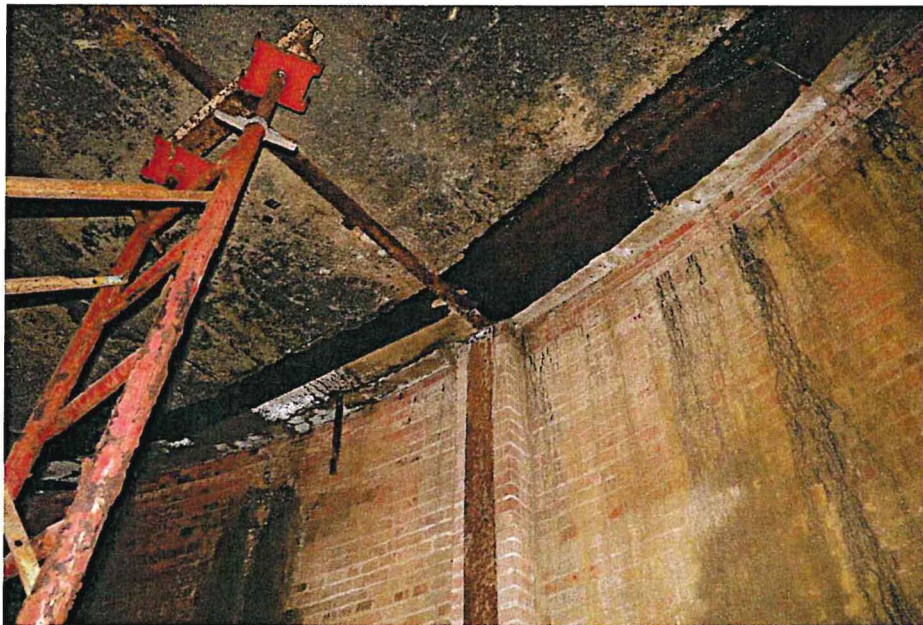
Photo 11. Embedded Beams and Columns in Basement

4. Embedded Columns and Beams: There are 10 embedded steel beams (with 3 3/8" flange width) in the main floor radially fanned from the center with the exterior ends supported by steel columns (with 6" X 3/8" flange) embedded in the basement masonry wall. All visible parts of the beams and columns are deteriorated with rust pack (Photo 11). Overall section loss is estimated to be 15% to 20%.
5. Temporary Shoring: There is temporary shoring under all 10 embedded beams in the main floor (Photo 17) and the main support frame near the two columns with 100% section loss at the top. There are also utility conduits in the basement (Photo 18).

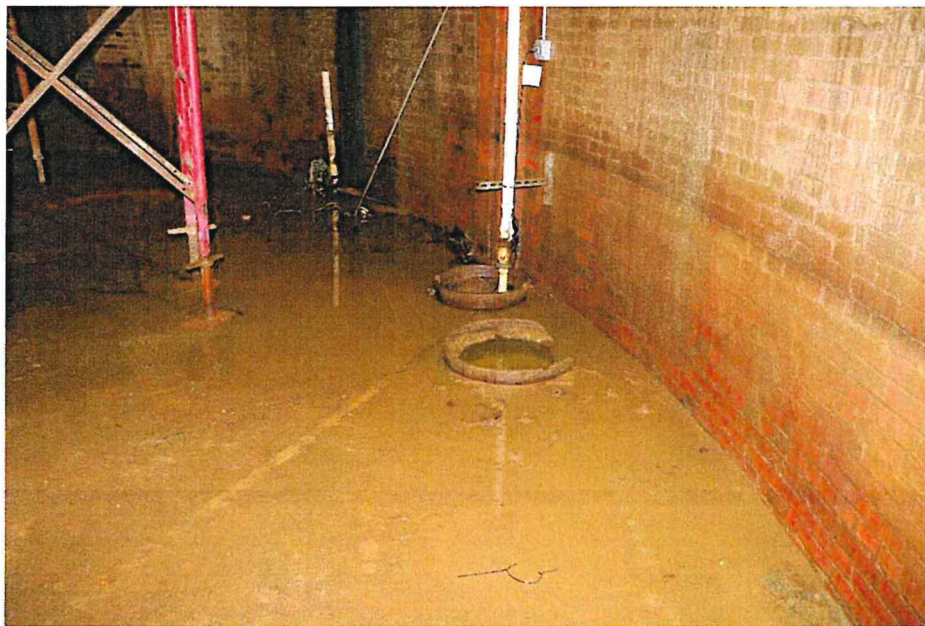
Photo 12. Ponding around Sump Cocks

There are four downspouts along the outside of the wall for the roof drain. Two of the downspouts are connected to the drainage system and the two on the south side are draining to the ground (Photo 20). There is an apparent local low spot in the grading on the east side of the building near the wall in the basement with active leakage (Photo 19). There are sump wells and pump drainage system installed in the basement (Photo 12).

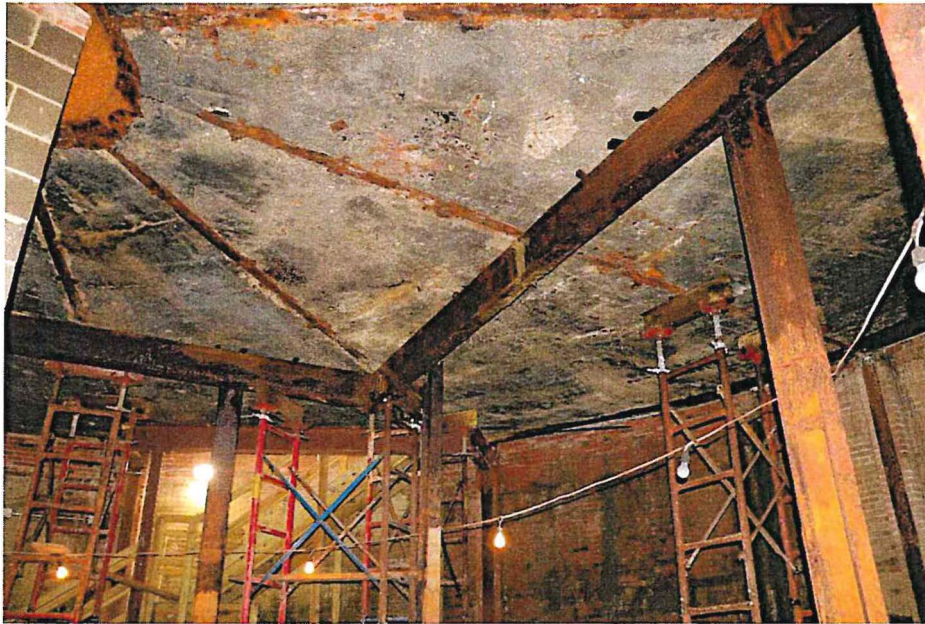
Photo 13. Main Support Frame in the Basement

columns (8"H X 4"W X 1/8"T Section) as detailed on the attached structure sketch. All beams and columns are deteriorated with rust scales (Photos 13, 15, 16). Overall section loss is estimated to be 15% to 20%. Two of the columns (14' Height) are buckled and leaning (Photo 14). Another two columns in the southwest corner were deteriorated with 100% section loss at the top.

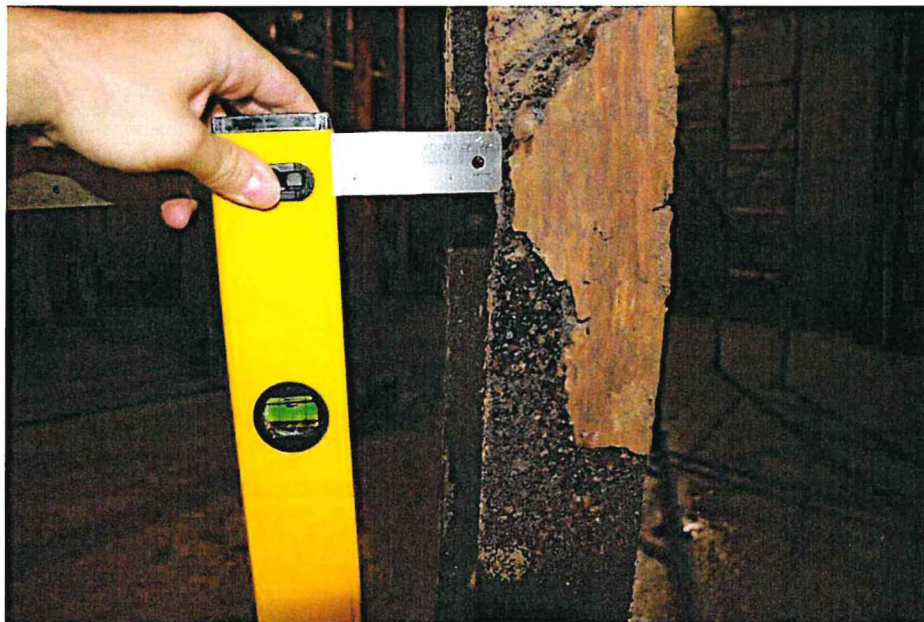
Photo 14. Column Buckled and Leaning

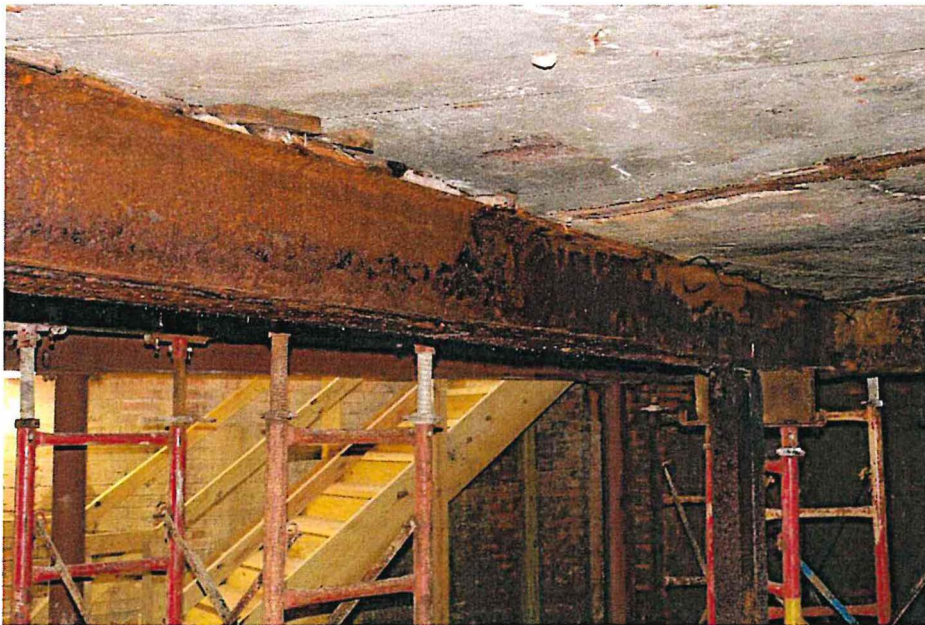
Photo 15. Main Frame Column with 100% Section Loss at Top

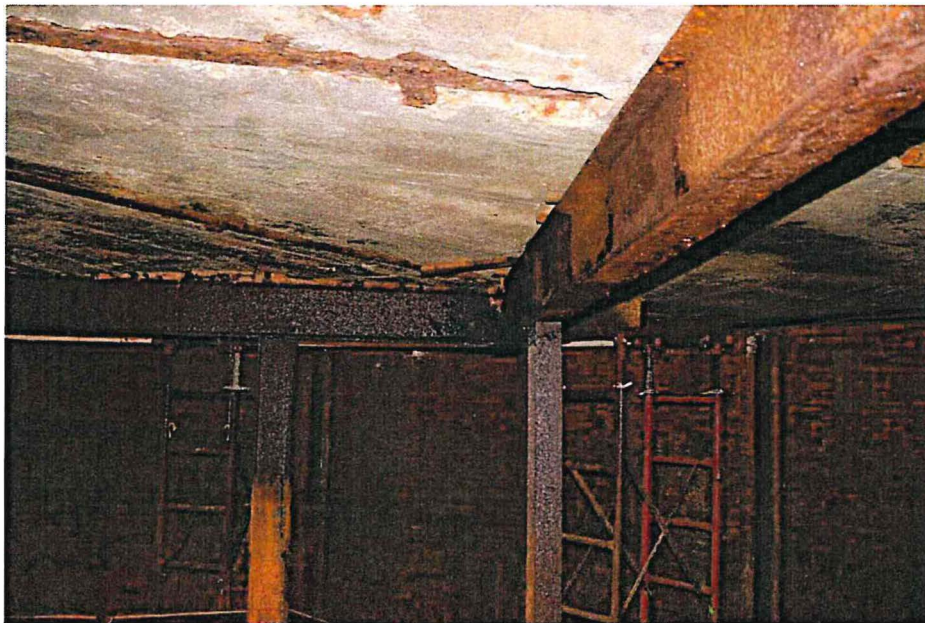
Photo 16. Main Frame Beam and Column with Rust Pack

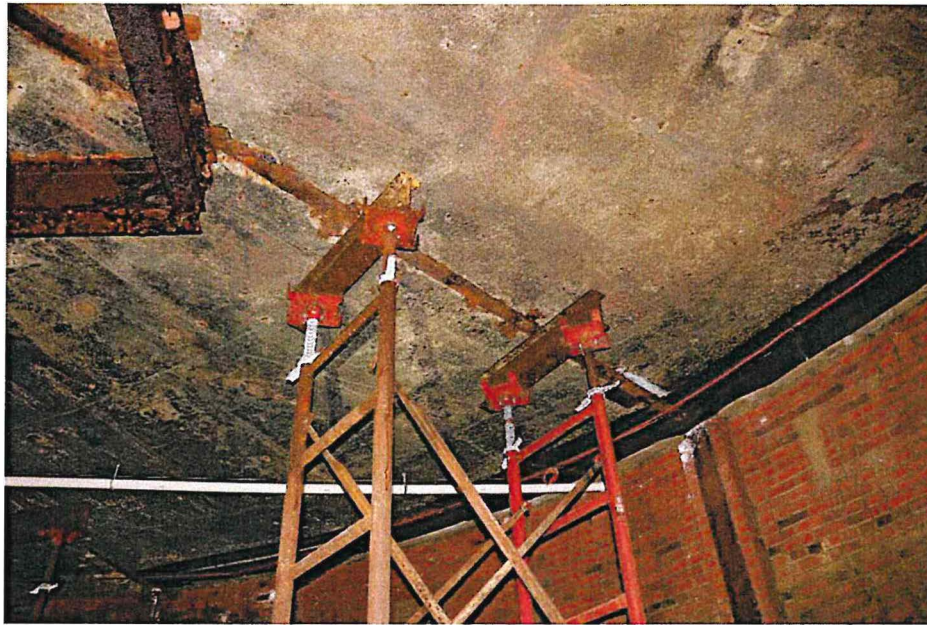
Photo 17. Temporary Shoring under the Embedded Beam

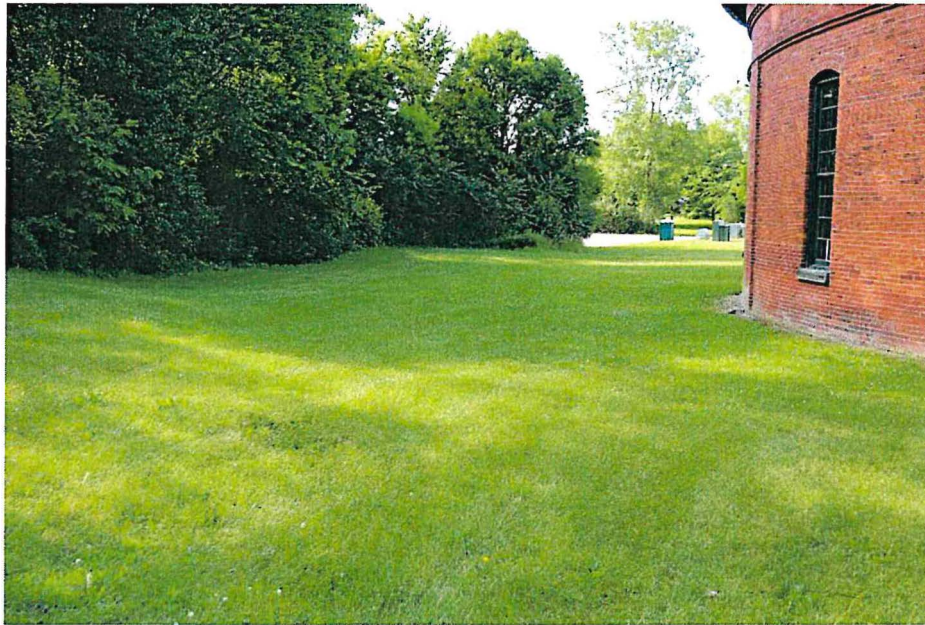
Photo 19. Low Spot behind the Building due to Grading

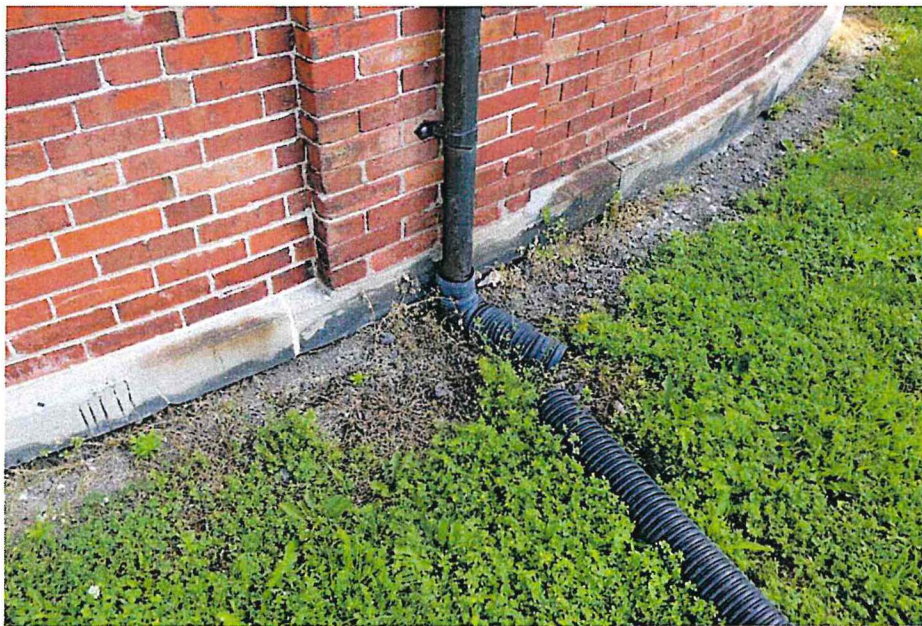
Photo 20. Downspout Drain to the Ground (Broken Extension)
