# MORGAN STREET RESERVOIRS ALTERNATIVES ANALYSIS REPORT

City of Oberlin, Ohio

September 21, 2020

## ALTERNATIVES ANALYSIS REPORT

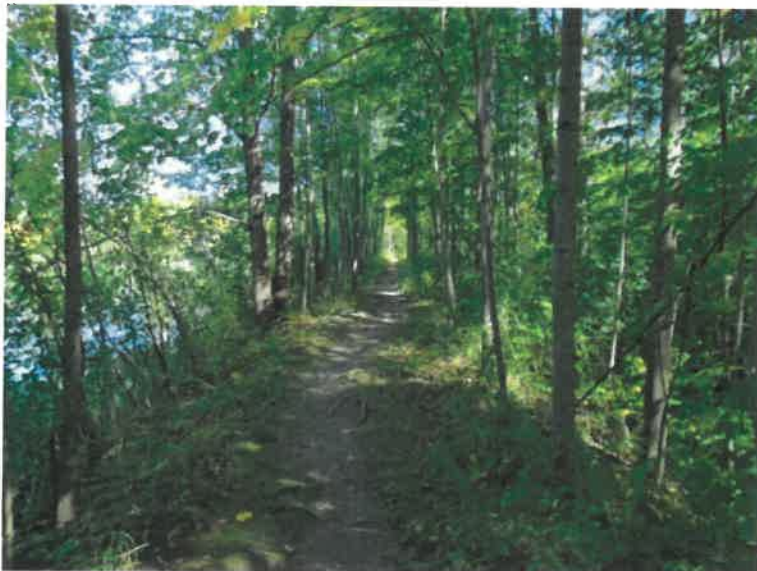
6. Dense trees and brush covered the majority of the embankment.

Notice the bare areas from the pedestrian footpath.

3. Seed the bare areas on the embankment to establish a proper grass cover. See the "Ground Cover" fact sheet for additional information.
4. Repair the erosion on the crest and interior slopes. See the "Ground Cover" fact sheet for additional information.

5. Repair the rodent burrows on the entire embankment. See the "Rodent Control" fact sheet for additional information.
6. Repair the footpaths on the crest. See the "Ground Cover" fact sheet for additional information.

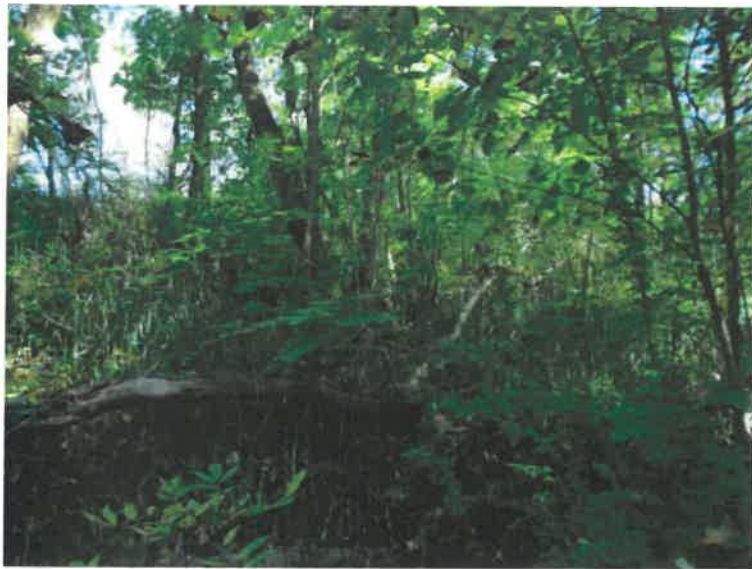
7. Dense trees and brush obstructed visual inspection of the exterior slope.

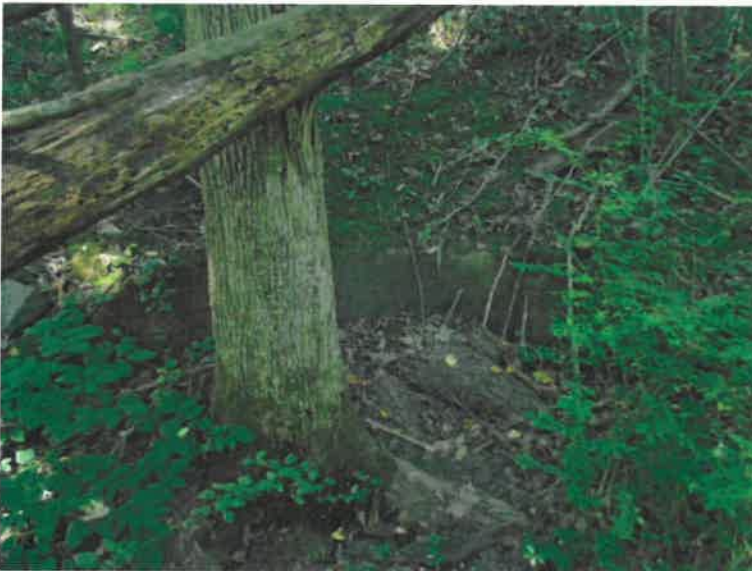
8. A concrete headwall was located along the southern exterior toe of Reservoir No. 2.

8. Monitor the wet area on the southern exterior toe monthly for any signs of increased flow, muddy flow, or instability on or adjacent to the embankment. See the "Seepage Through Earthen Dams" fact sheet for guidance in monitoring the wet area and for additional information. Please note that repairs may be needed if this problem worsens.

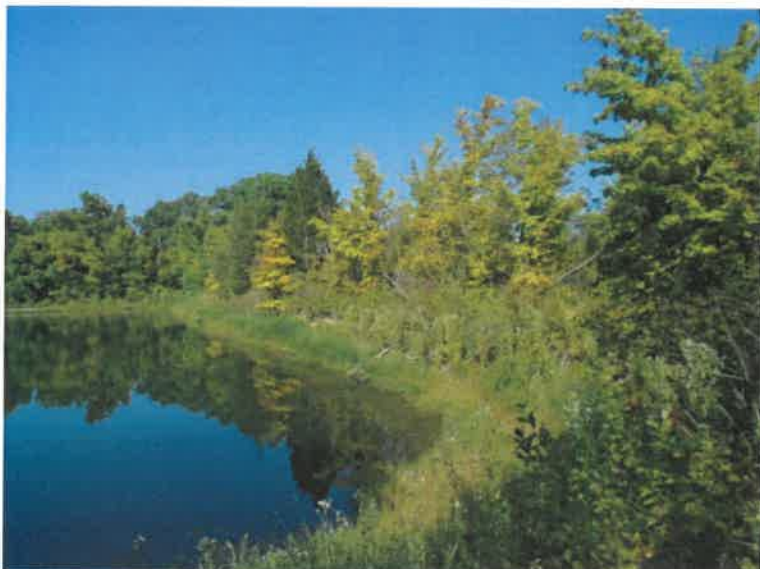
9. The common embankment between the two reservoirs.

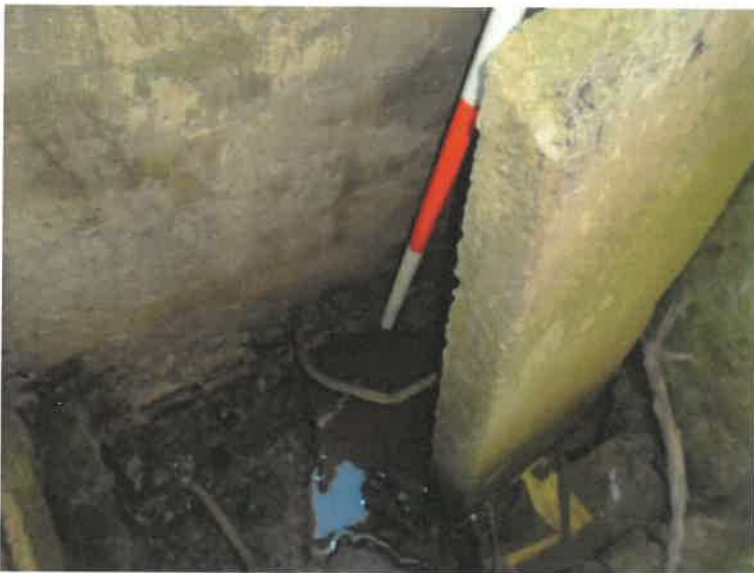
14. The interior of the catch basin in photograph no. 13.

Notice the obstructions in the catch basin.

1. In accordance with OAC Rule 1501:21-13-03 (D), every upground reservoir shall have an overflow or other device to preclude overfilling of the reservoir during normal filling operation. Prepare plans and specifications to install an overflow or other device. See Discussion Item #1 included in this section for additional information. **This item has been noted previously and the appropriate time period for completion has already been exceeded. The owner must complete this item immediately.**
